# Lower Ashley Road, Bristol

# **Remediation Strategy**

CS-0554

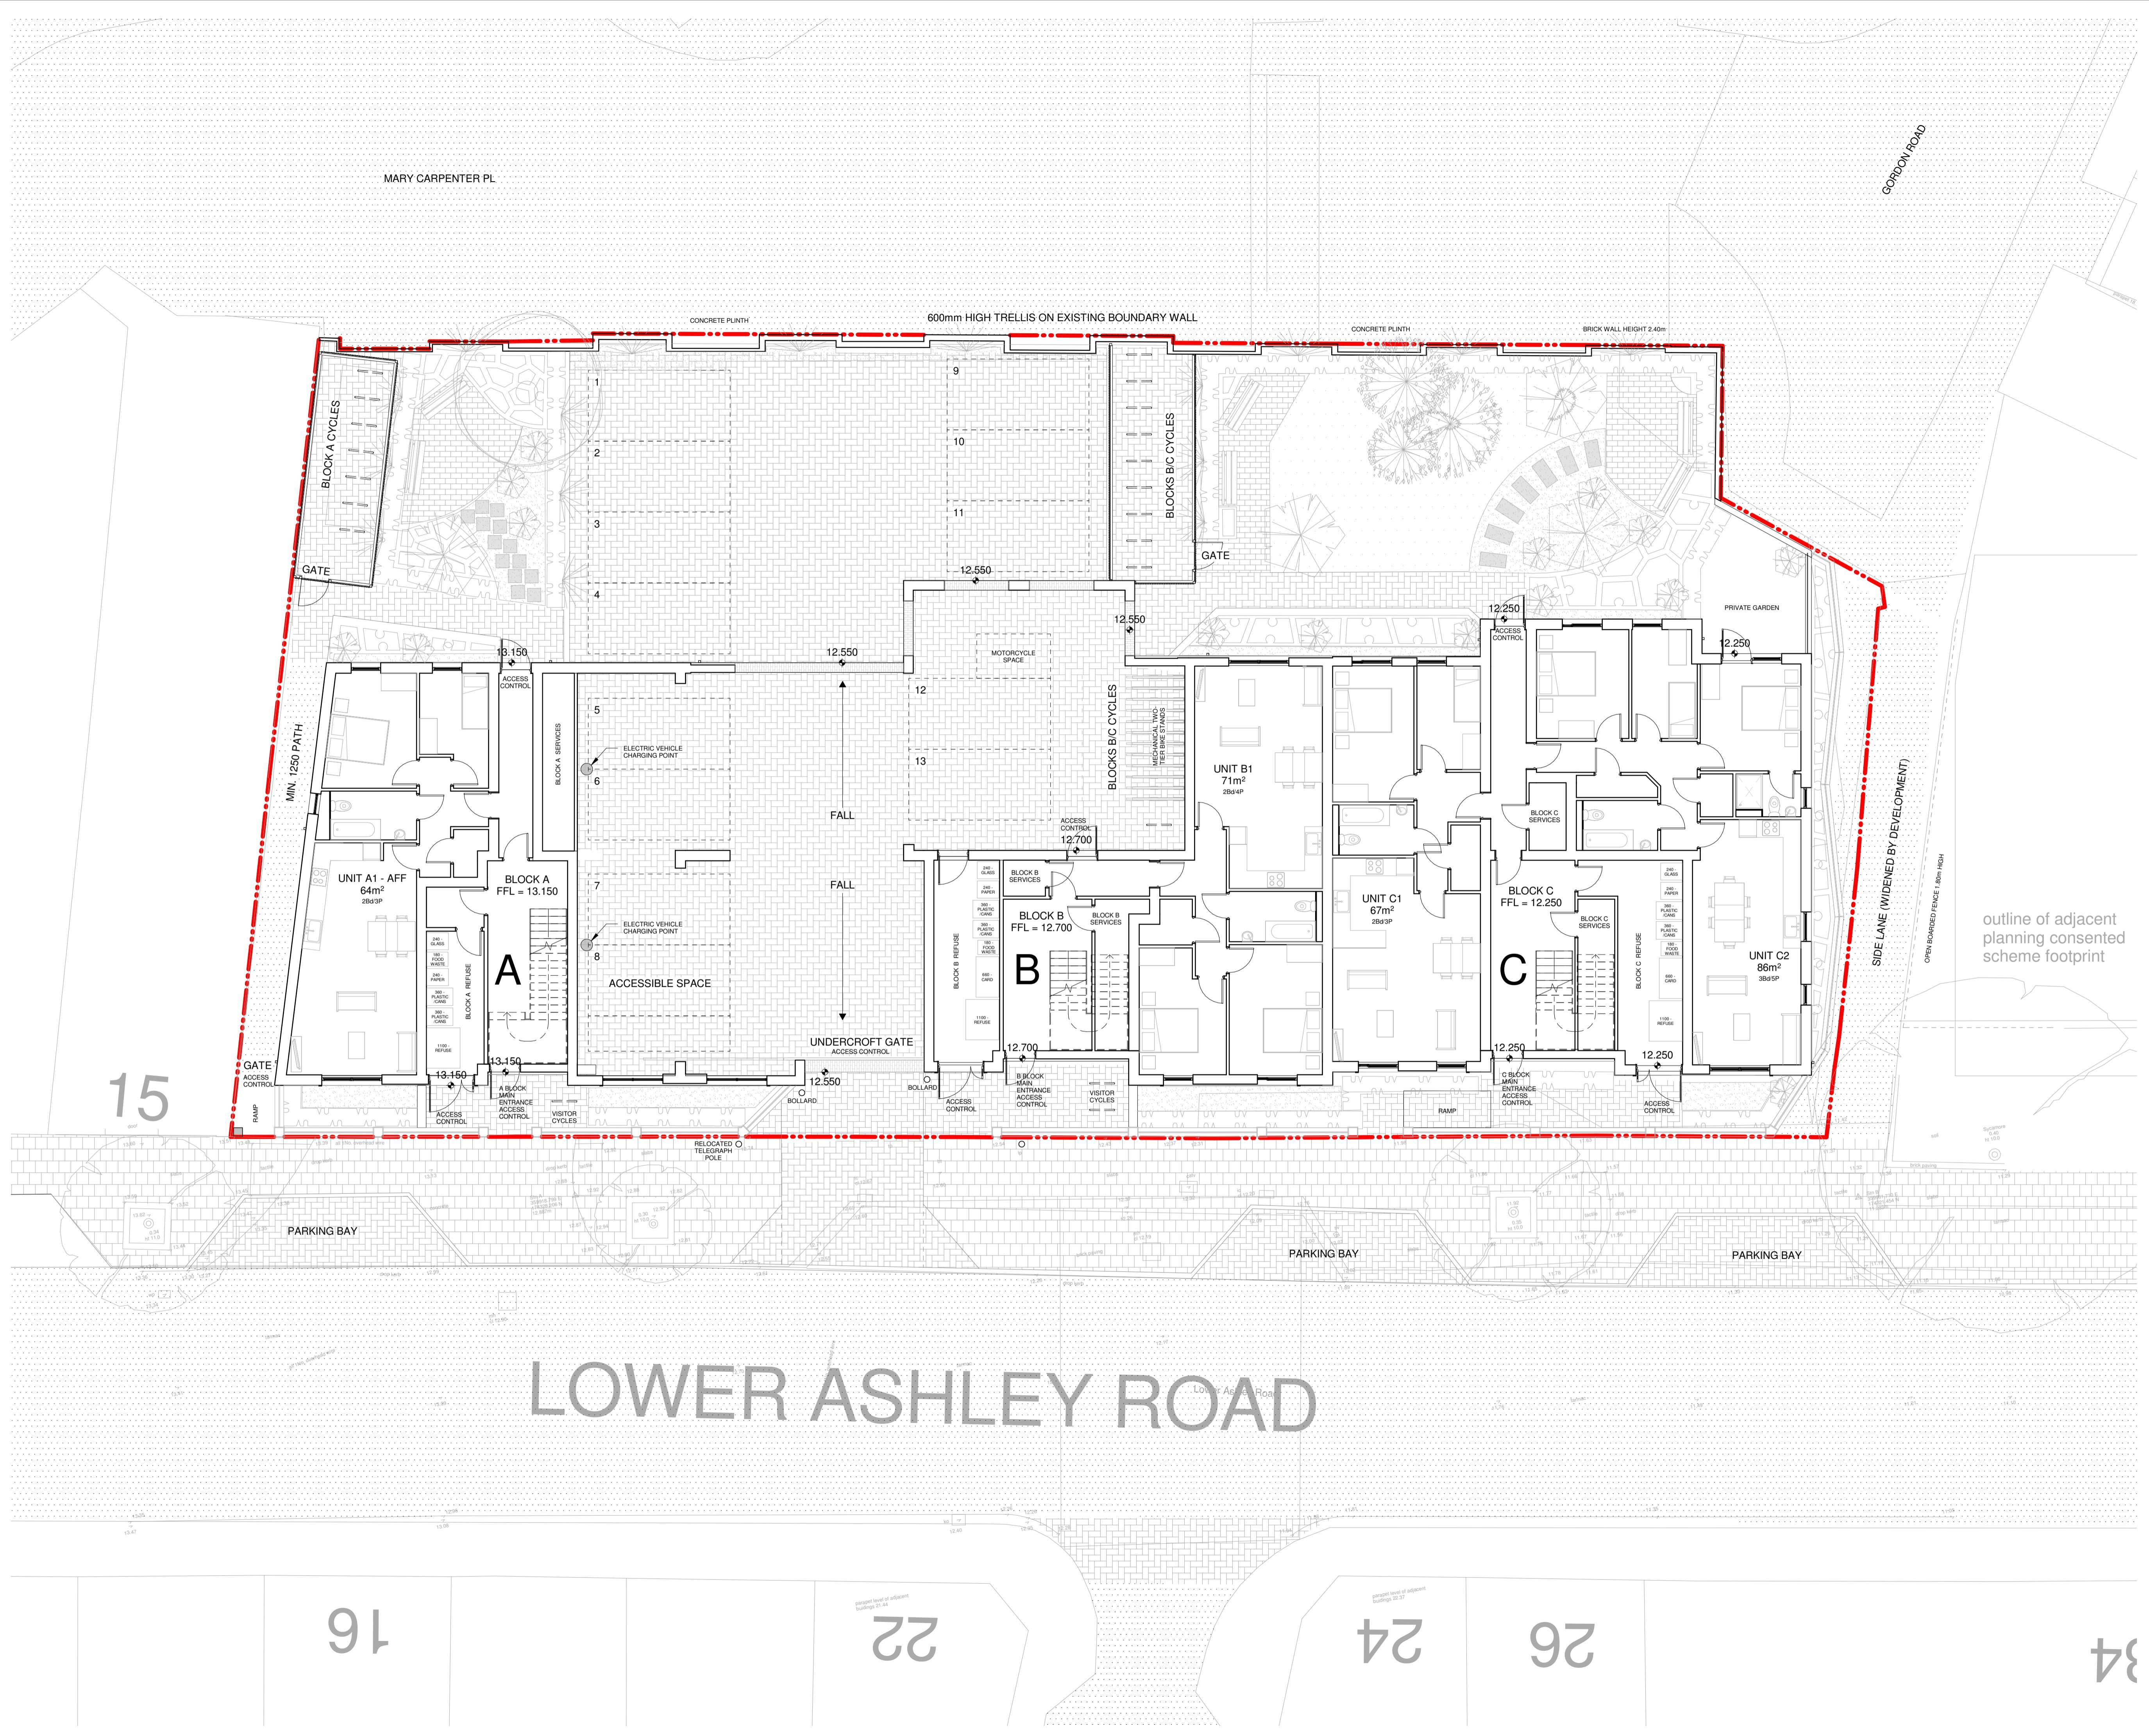
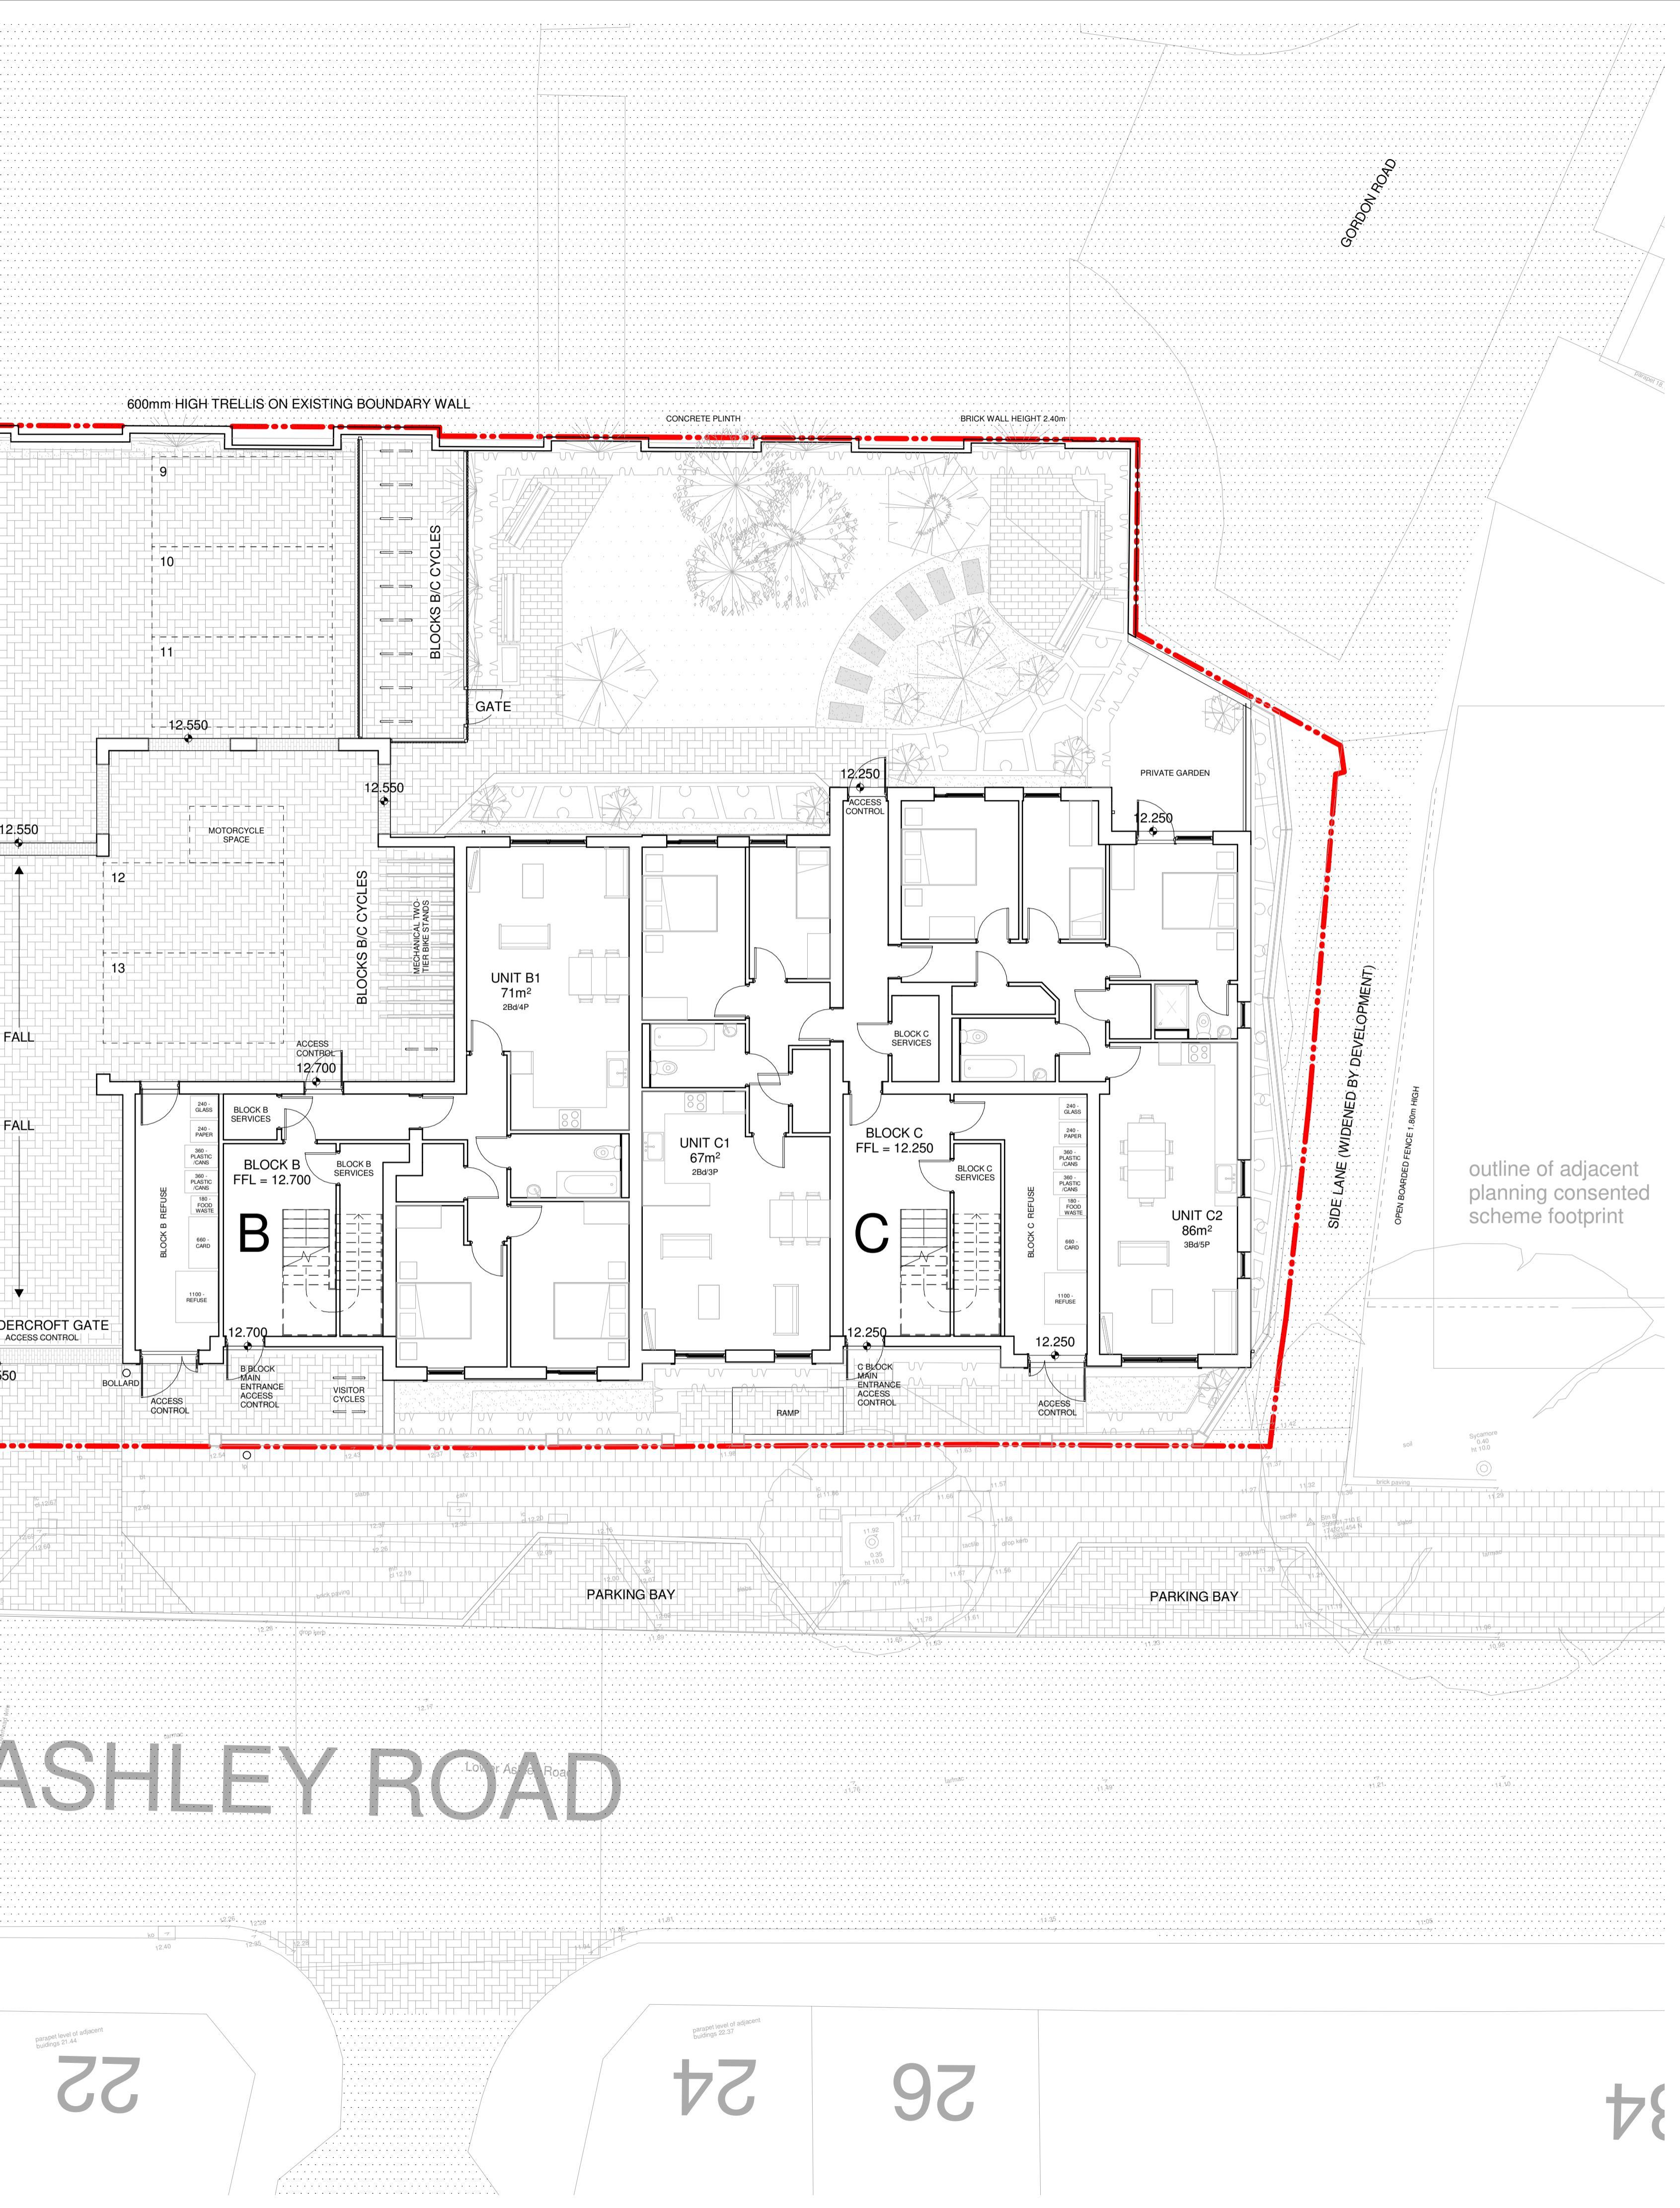
Date Drawn Checked PCW April 2019 LD Drawing No. Rev. Job No. Stage 2510 P 201 D

PROPOSALS SUBJECT TO: SITE SURVEY; STATUTORY APPROVALS; DESIGN DEVELOPMENT.

Proposed Development and Landscaping Plans are included within Appendix A.
